ABLE INSPECTIONS CO.
Inspecting Since 1976
713 465-0000

Introduction

In accordance with your instructions, the undersigned inspector has made a limited foundation inspection, in addition to inspection of roof systems, perimeter grounds, mechanicals, electrical, HVAC, wood destroying insects, sprinkler system and vehicular parking of the above referenced low-rise office building.

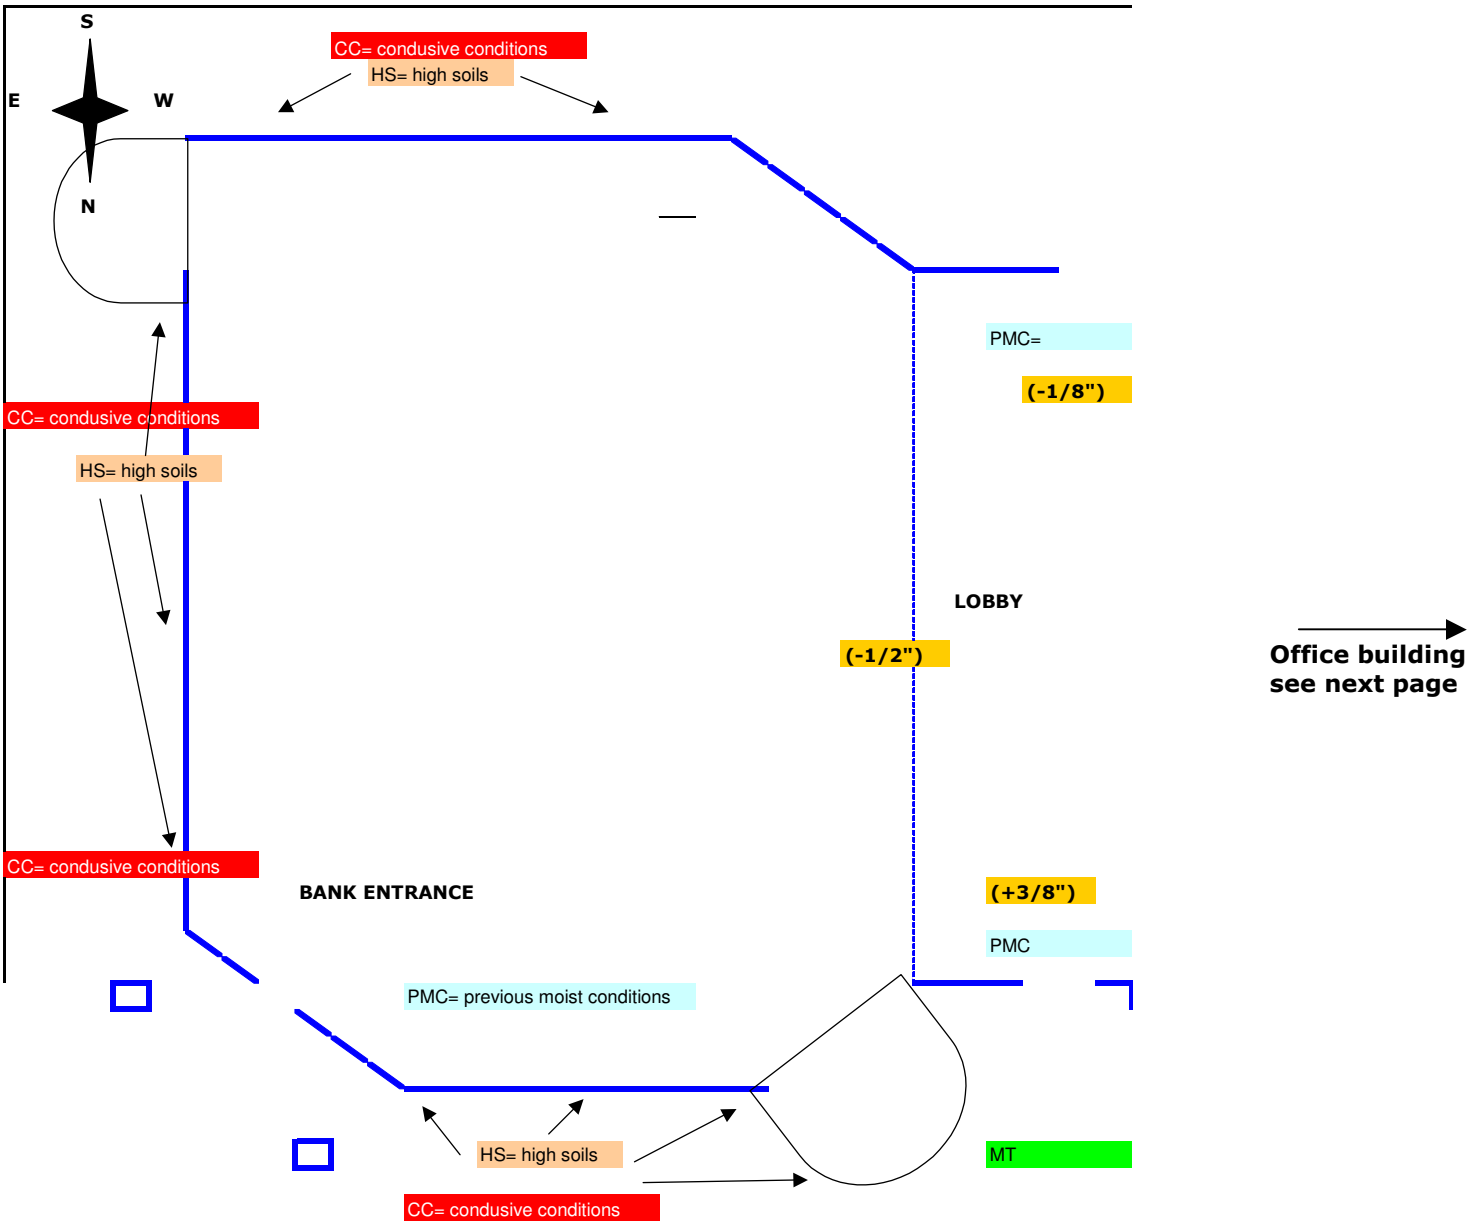
OFFICE BUILDING FLOOR PLAN

The results of our survey indicate the first floor of this office building to be reasonably level. The high point of the foundation slab is located at the north lobby. The surface elevation at this point is approximately 3/8 inch above the reference elevation of zero. The low point of the slab is located at the northwest hallway/stairs and toward east area of bank and is approximately 1/2 - 5/8 inch below the reference elevation of zero.
