MOLD INSPECTION REPORT

Harvard Preserve January 16, 2007

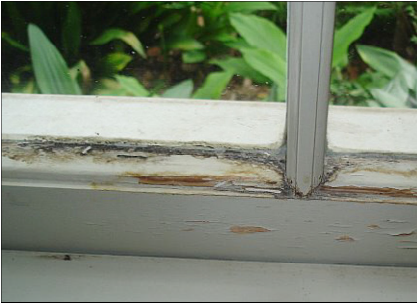
Observations: Rotted and damaged wood with some slight mold was observed on numerous windows throughout this residence. Some slight mold was also observed at some of these windows. The master bathroom tub window has staining on the exterior side of the shutters over this tub. Metal cap flashing is not installed above these windows, which would help deflect rainwater from these windows. Wood windows are attractive, yet vulnerable to the effects of moisture.

Rotted wood with slight mold growth at north master bedroom bay window

Recommended Action: Please contact an experienced window contractor to provide a complete evaluation and recommendations for improving this situation to prevent rainwater from entering these windows.

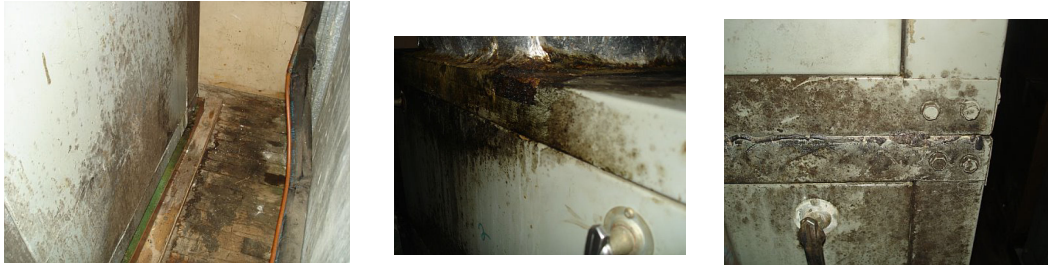
Observation: Mold growth was observed in several areas on A/C equipment in this room. Stains from leak conditions were observed along with sweating on the equipment and water in the emergency pan. HVAC units typically experience some mold growth from the mixture of condensation moisture and dust in attic spaces. The mold growth observed in this area is wider spread than what is routinely seen as a result of greater availability of moisture due to the leak conditions and sweating of this equipment.

Mold growth on HVAC equipment in second floor equipment room

Recommended Action: Consult with HVAC contractor to determine the cause of these leak conditions and for proposals on repairs. Since this equipment room is connected to a finished attic space, which is planned for use as a living area, I would recommend cleaning the mold off of this equipment and replacing any air duct tape with mold growth. The metal cabinets can be cleaned with a solution of detergent and water to remove the mold growth. **I do not recommend using bleach and water solutions to clean mold** because bleach can be harmful to your health without ample ventilation.

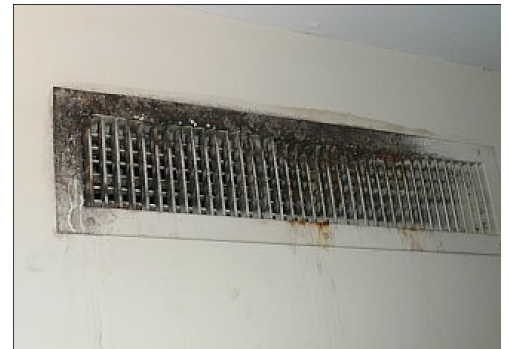
Observation: Significant mold was observed on air registers in the finished attic near the HVAC equipment closet.

Finished attic air register

Recommended Action: All of these air registers need to be thoroughly cleaned or replaced. Since these air registers are made of a hard surface a solution of water and detergent will remove the mold. A slight amount of mold growth can be seen extending down the wall. From the surface this does not appear to cover a large area. If you decide to clean this small area then I would recommend using a HEPA-filter vacuum cleaner since water and detergent will not be sufficient to clean mold off this material.

The source of moisture in the HVAC equipment room needs to be corrected so mold does not return.

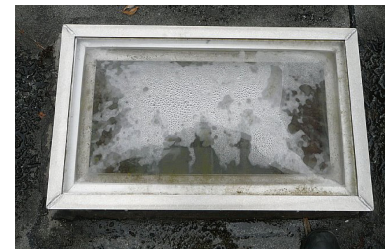
Observation: The skylight lenses on this residence show signs of damage, cracking and previous repairs/sealant. One of the skylights also has excessive condensation.

Moisture in
bathroom skylight

Recommended Action: We recommend replacing skylight lenses on this residence to prevent water intrusion from the vulnerable access points.

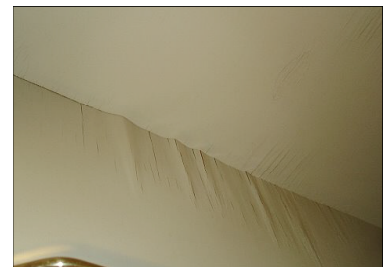
Observation: Stains from moisture/leak conditions were observed on the ceilings of the garage, quarters and front office. Stains were also observed in the second floor HVAC equipment room from leakages off of this equipment and the freon and drain piping.

Recommendations: Some of the ceiling stains may be from previous roof leakages. We recommend retaining the services of a reputable and qualified contractor in the immediate future to determine exactly where this moisture is coming from, to examine all areas for hidden damages and to expose any possible hidden mold/mildew and provide estimates for the appropriate repairs.

We further recommend having the HVAC contractor determine the source of the leak conditions in this area and make recommendations for repairs.

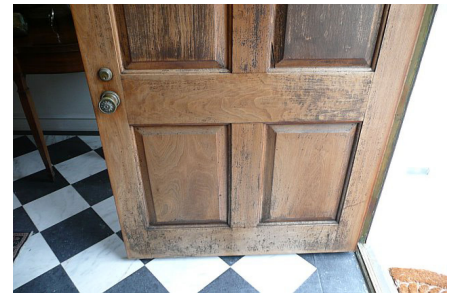
Observation: Mildew staining was observed on the exterior side of the front pedestrian door.

Recommended Action: This door can be cleaned and resealed at the buyer's convenience. A wood floor cleaner can be used to clean the mold off this surface.

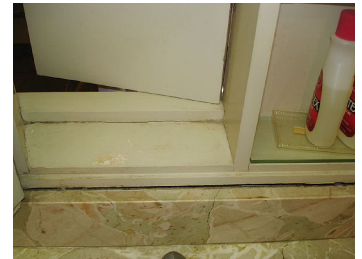
11. Slight Mold at right edge of "Her" master bathroom pass through window

Recommended Action: This area simply needs to be cleaned with a wood floor-cleaning product to remove this mold and repainted, as desired.

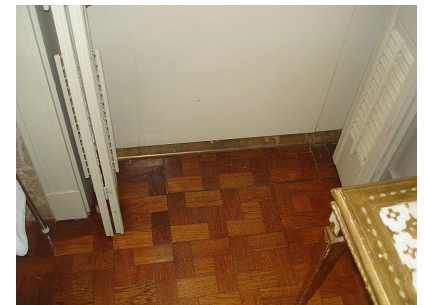
Observation: Floor tiles are loose inside the master bathroom pedestrian door leading to the patio and pool area. Damaged wood was observed just outside this door. These conditions may be the result of moisture in this area.

Recommended Action: Please have a contractor evaluate this area to determine if moisture is entering into this room.
