ABLE INSPECTIONS CO.
Inspecting Since 1976
713 465-0000

Introduction

In accordance with your instructions, the undersigned inspector has made a limited foundation inspection, in addition to inspection of roof systems, perimeter grounds, mechanicals, electrical, HVAC, wood destroying insects, sprinkler system and vehicular parking of the above referenced low-rise office building.

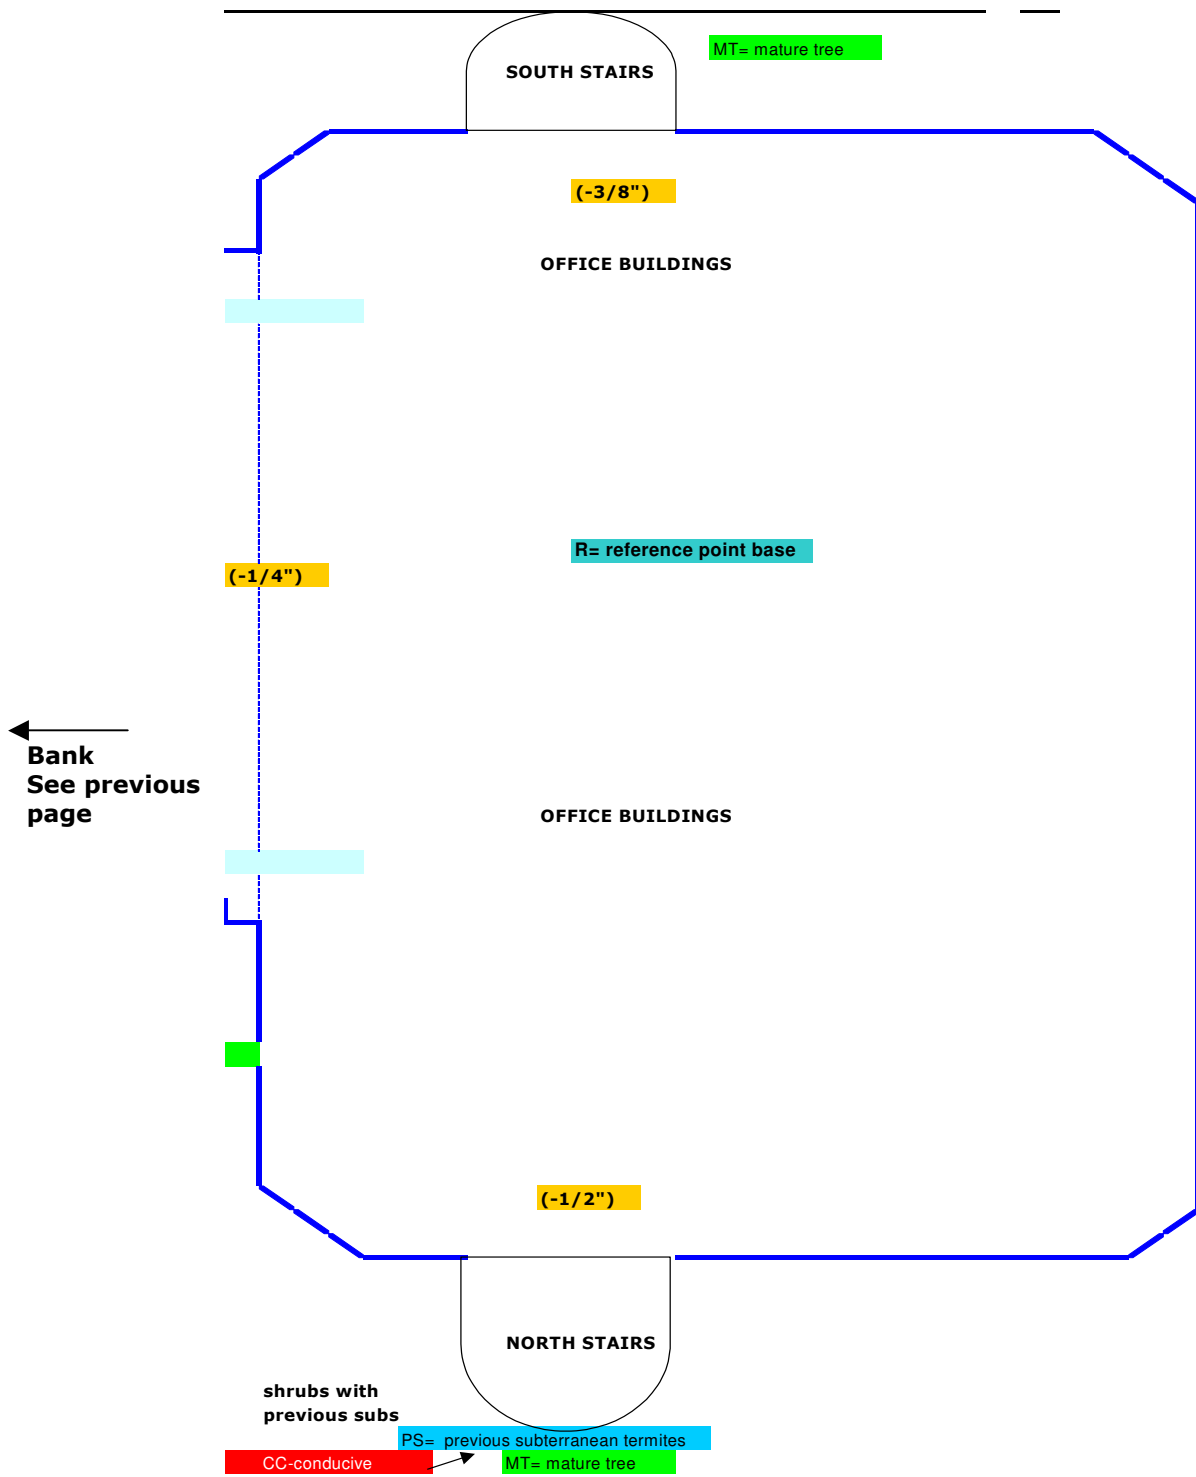
FLOOR MEASUREMENTS

The results of our survey indicate the first floor of this office building to be reasonably level. The high point of the foundation slab is located at the north lobby. The surface elevation at this point is approximately 3/8 inch above the reference elevation of zero. The low point of the slab is located at the northwest hallway/stairs and toward east area of bank and is approximately 1/2 - 5/8 inch below the reference elevation of zero.
